# **Fire Endurance Tests of Steel Sandwich Panel Exterior Wall and Roof/Ceiling Constructions**

B. C. Son

December 1972

Final Report

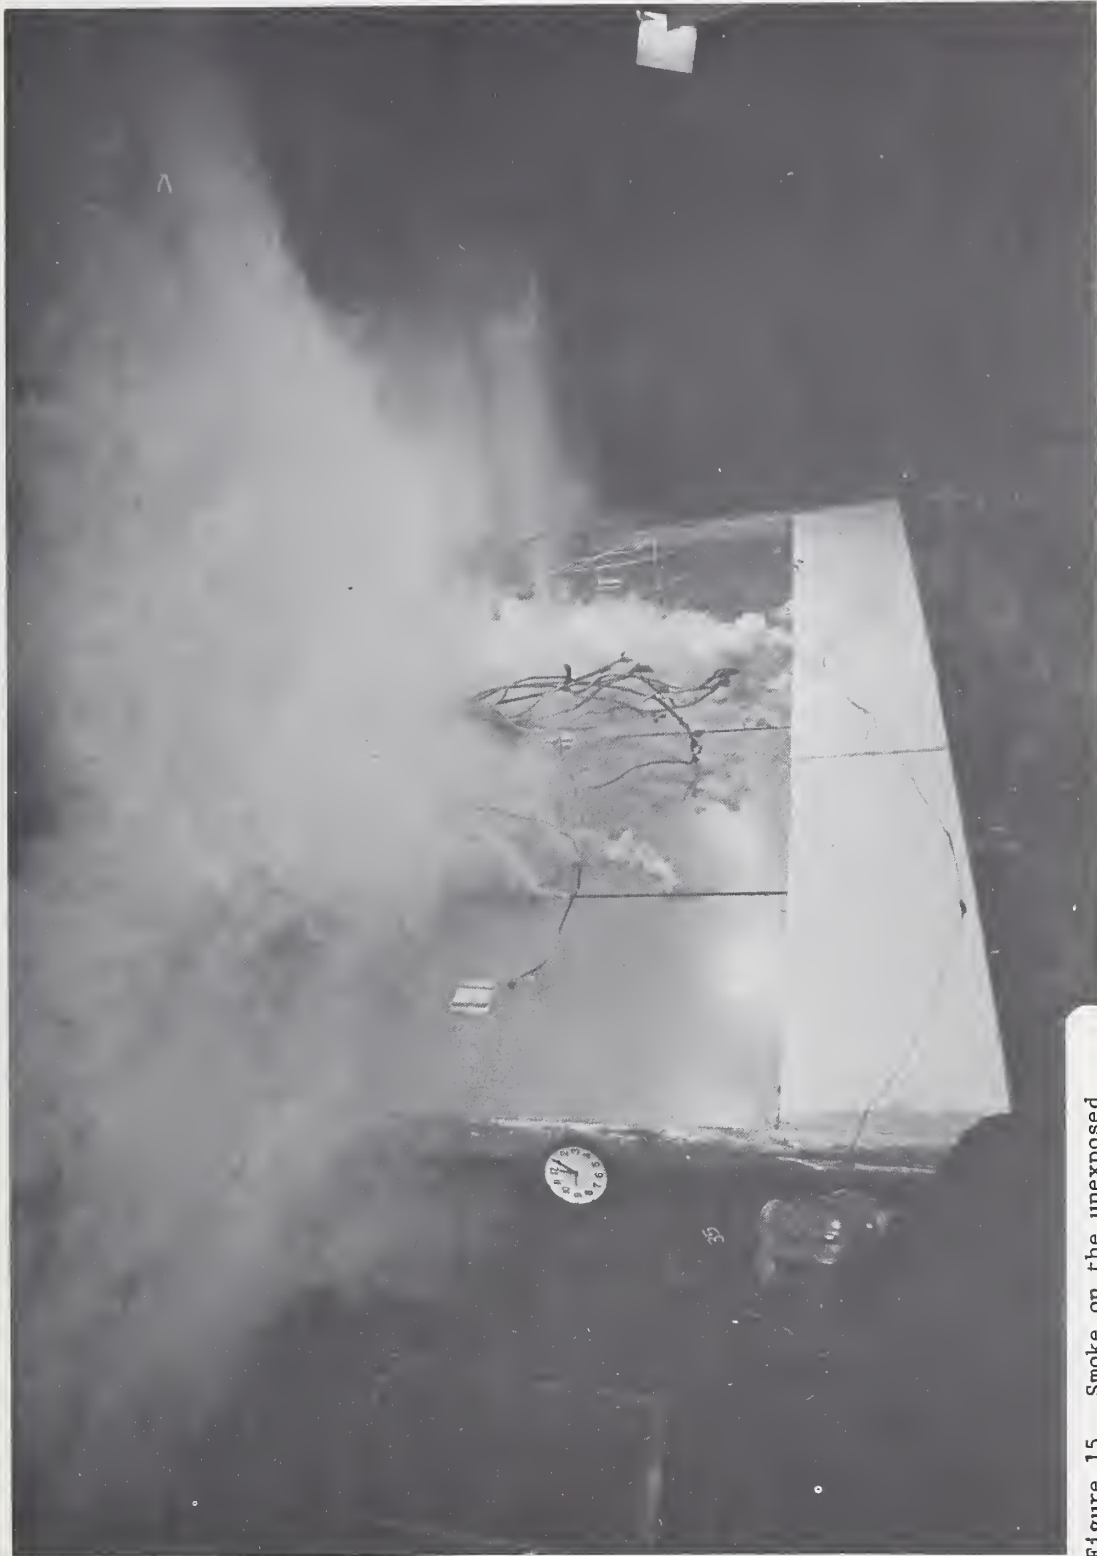
Figure 15. Smoke on the unexposed side of the wall. Test time of 5 min.

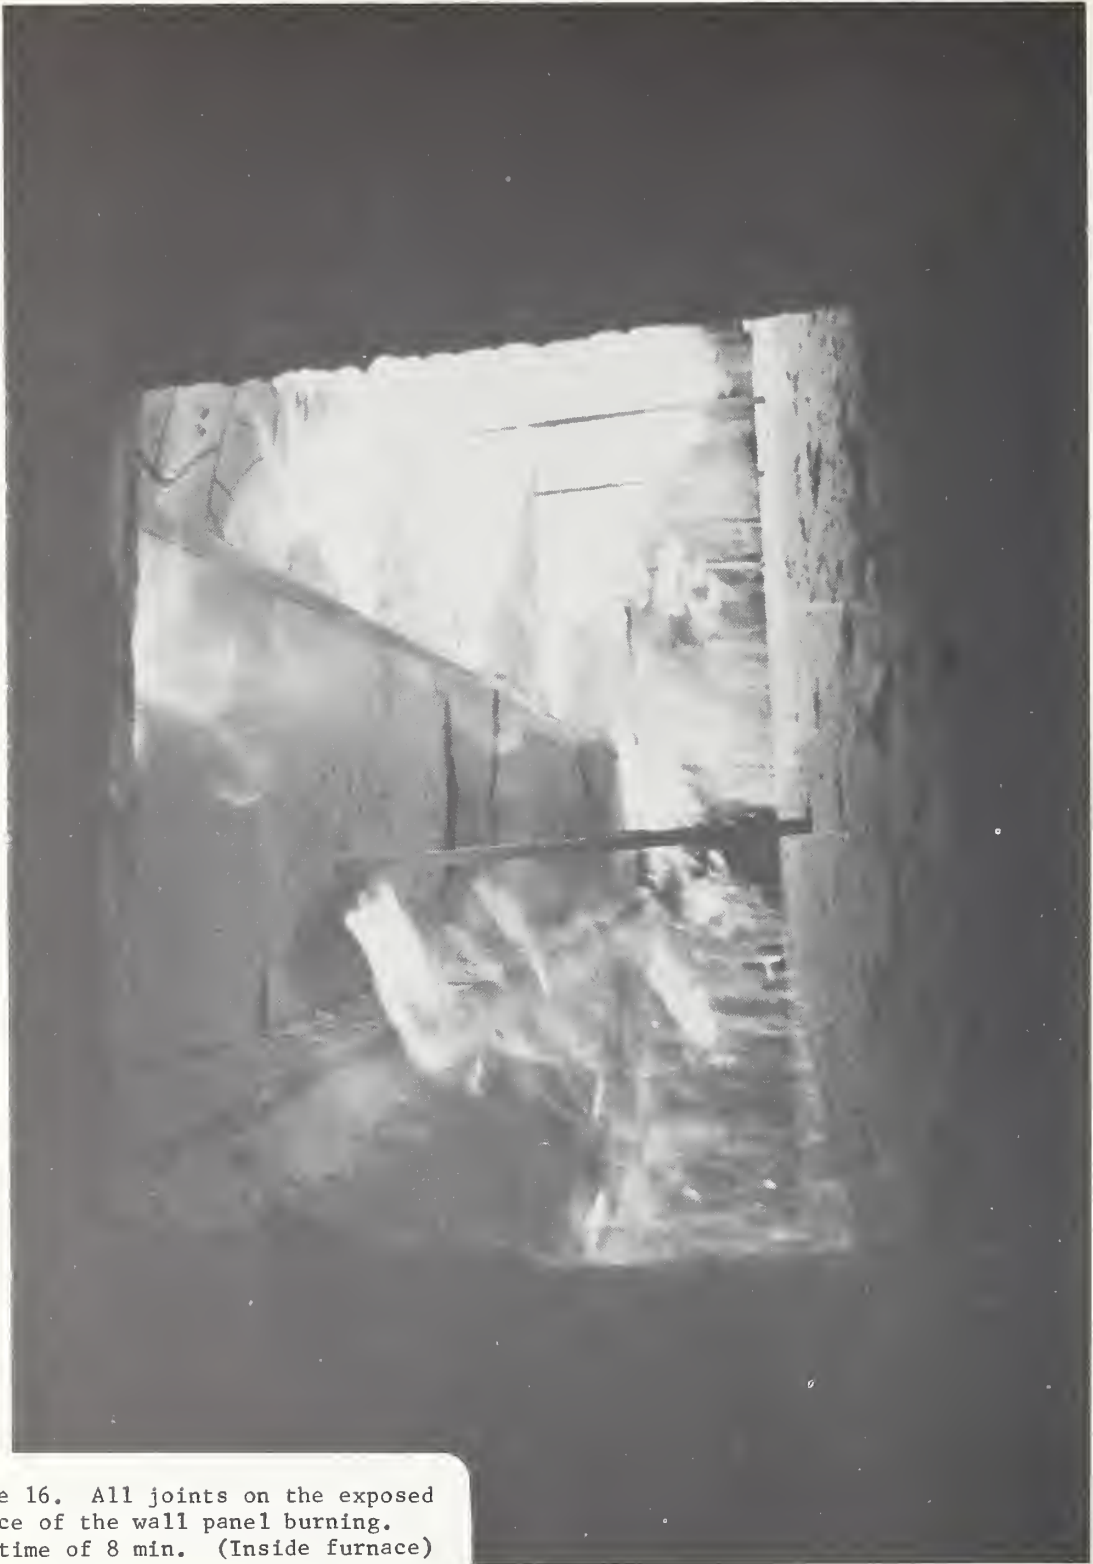
6:00	Smoke seemed to clear up.
8:00	All joints on the exposed surface flaming severely. (Figure 16 is a photograph taken through observations window.)
9:00	The color of the unexposed surface appearing to change from light buff to brown. An average temperature rise of 139°C above its initial temperature on the unexposed surface was observed.

Figure 16. All joints on the exposed surface of the wall panel burning. Test time of 8 min. (Inside furnace)

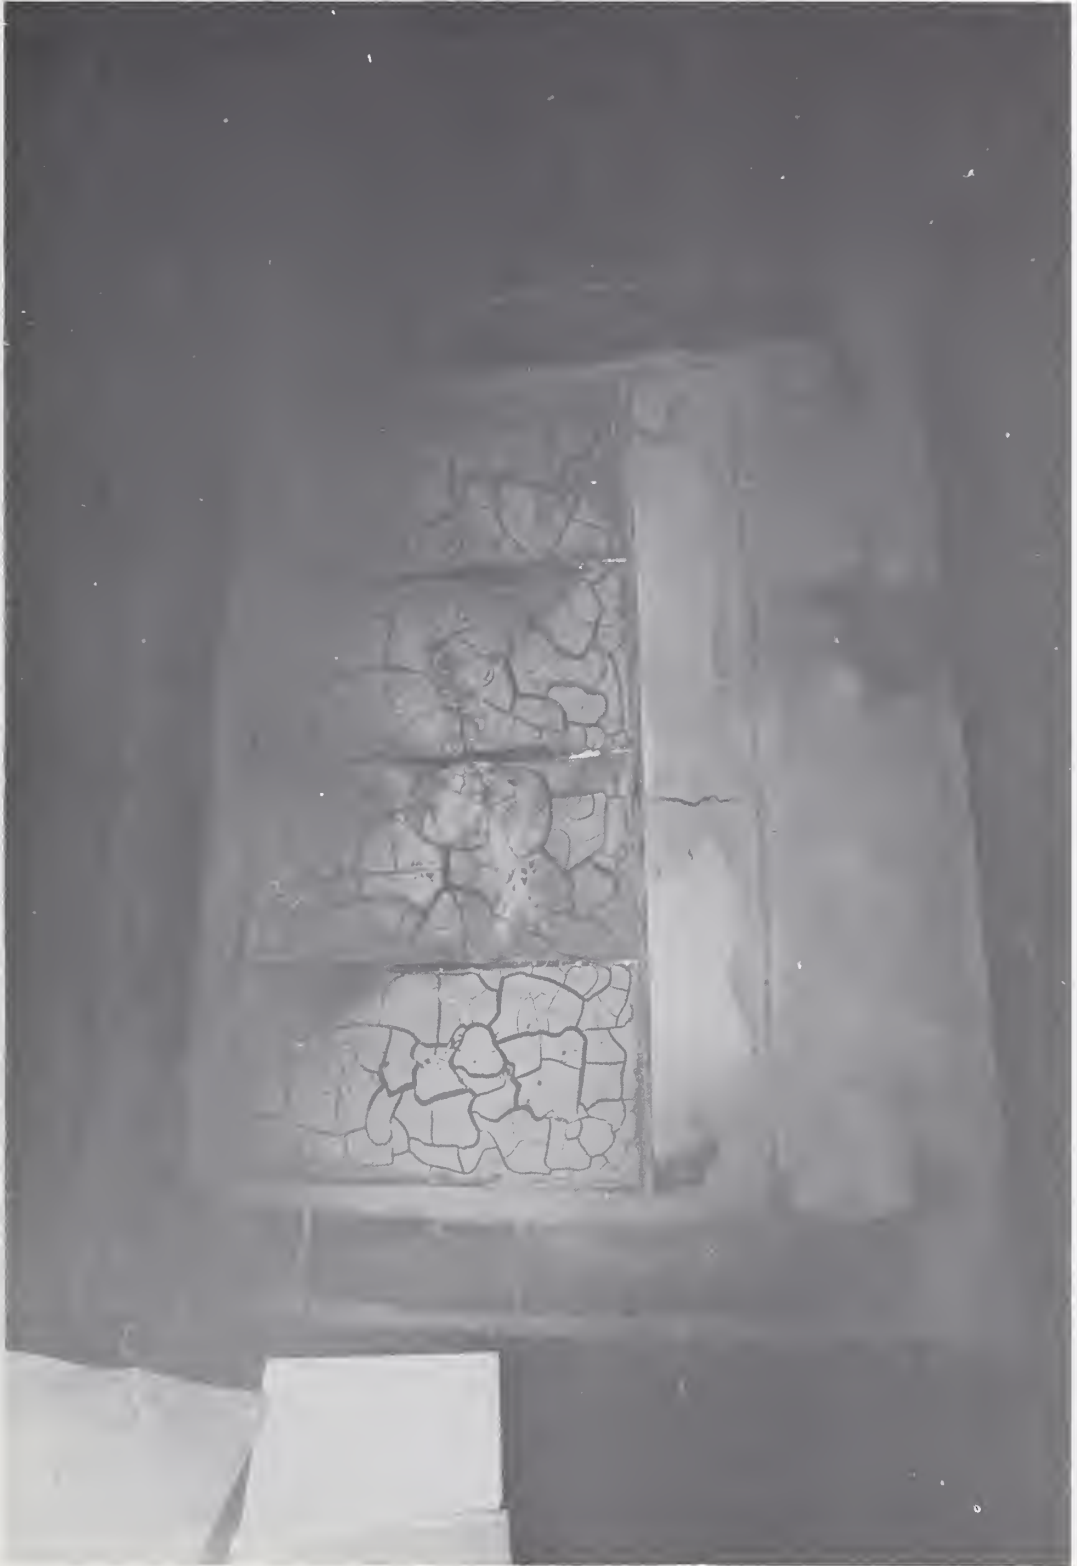
Figure 17 is a photograph showing the fire side of the panel after it was removed from the furnace just before extinguishment of the fire. Surfaces were buckled and most of the wood members, paper honeycomb, and polyurethane foam were consumed.

Figure 17. The fire side of the wall panel after it was removed from the surface just before extinguishment of the fire.

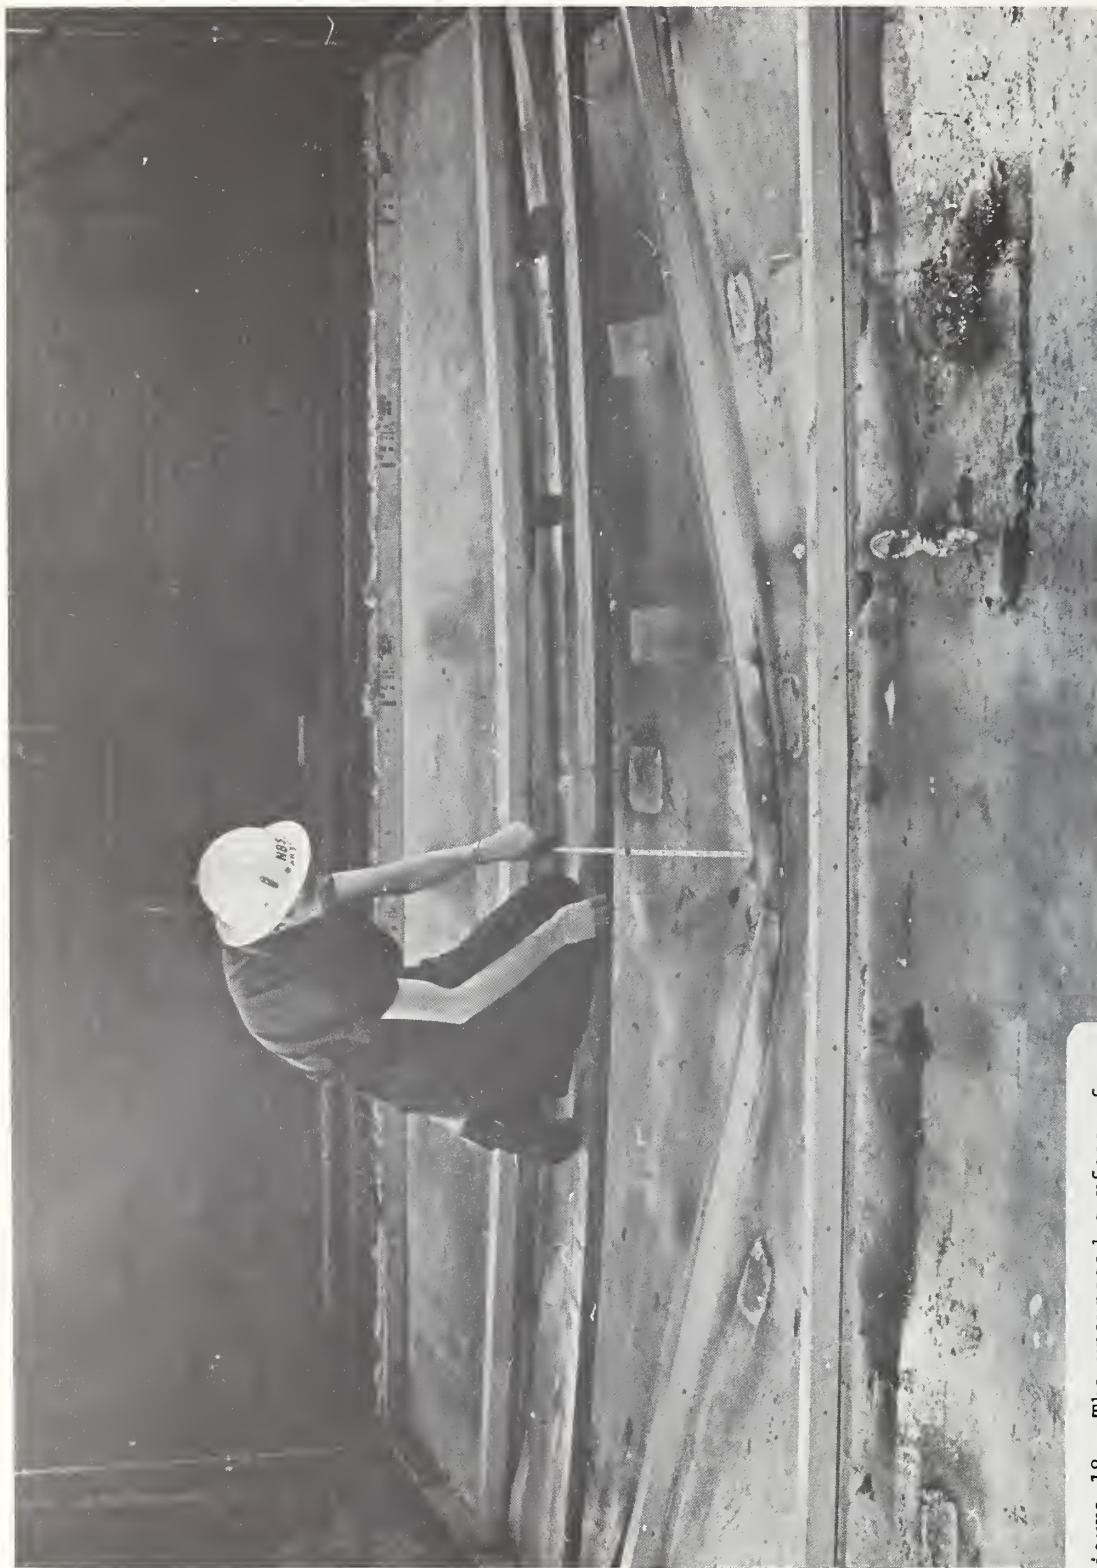
The photographs in Figures 18 and 19 show the unexposed surface of the assembly after the loading rig was removed and the exposed surface at the failed joint, respectively, at the end of the test.

Figure 18. The unexposed surface of the roof/ceiling assembly after the loading rig was removed at the end of the test.

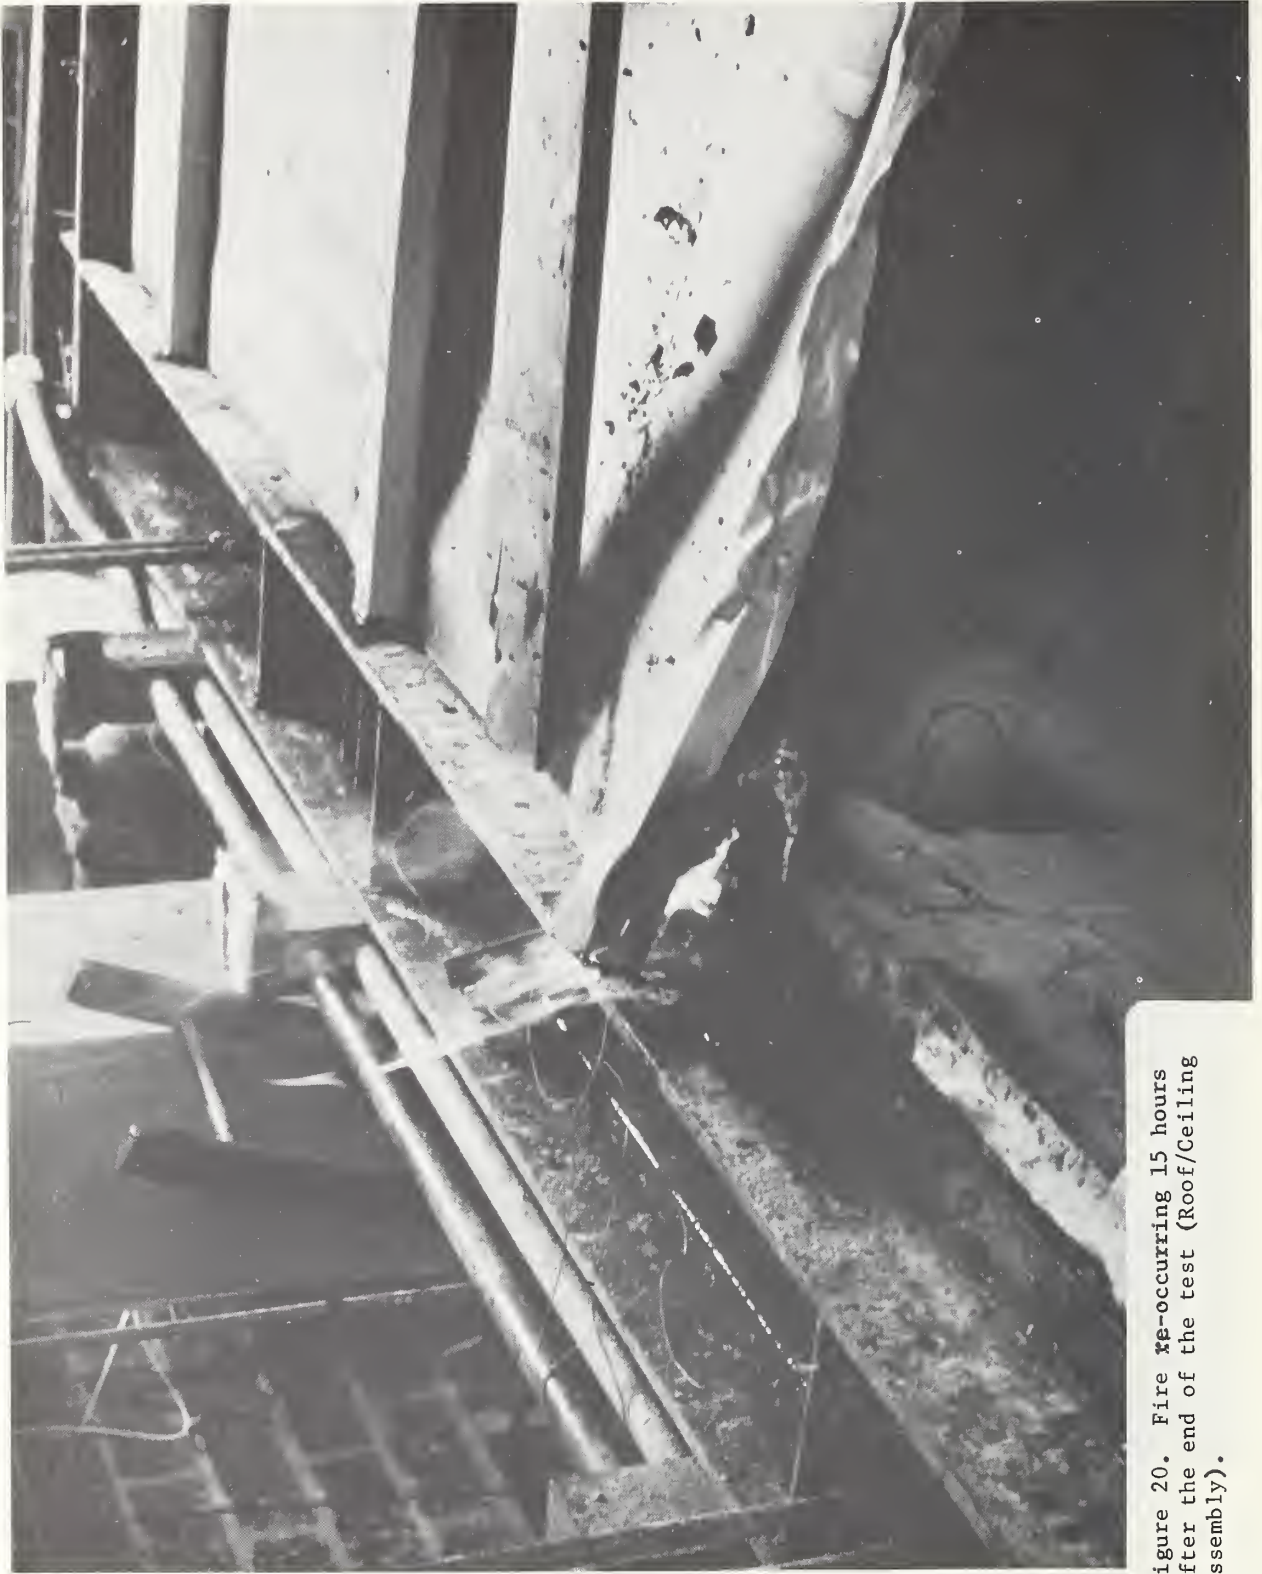
When the specimen was being dismantled 15 hours after the end of the test, some flaming occurred at the east end of the second joint from the north end to a height of several feet (Figure 20).

Fifteen hours after the end of the test, the specimen, when it was dismantled, burst into flame at the east end of the second joint from the north end. The height of flame was approximately 3 ft. (See Figure 20.)

Figure 20. Fire occurring 15 hours after the end of the test (Roof/Ceiling Assembly).
